Manhole Inspection Summary

Manhole # S43O__002MH

Location Address: **1417 thames st**

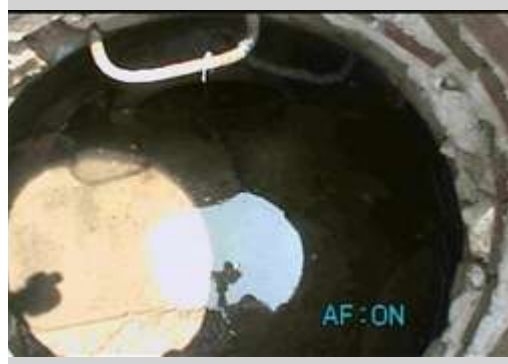
Top View

top view & steps

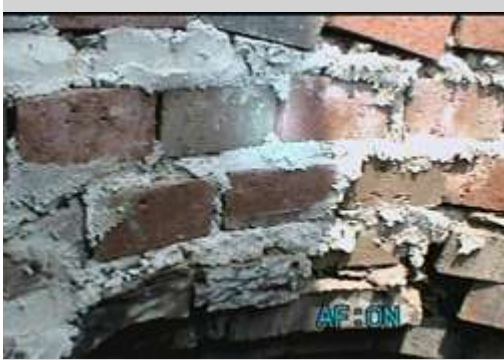
Defect 1

Condition: ☐ Sound ☐ Cracked ☐ Root Intrusion ☐ Loose Brick ☒ **Deteriorated**

corbel deteriorated

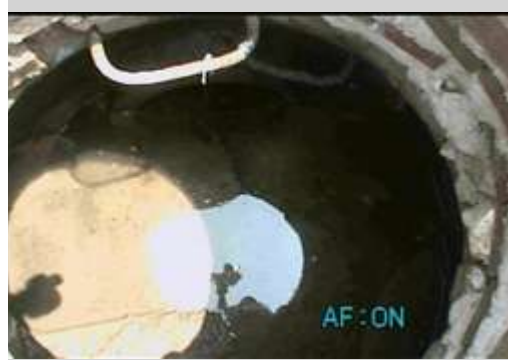
Defect 2

Condition: ☐ Sound ☐ Cracked ☐ Root Intrusion ☐ Deteriorated ☐ Leaks ☒ **Debris**

Count: **2** Missing: **0** ☒ **Corroded**

steps corroded, bench debris, channel debris

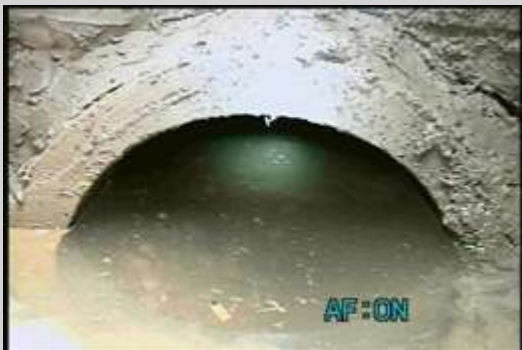
12 O'Clock Outflow

21 in. Circular Gravity Sewer
Pipe Out @ 12 O'Clock

Invert Depth: **4.94** (ft.) Flow Characteristics: **Slow**

Infiltration: **None**

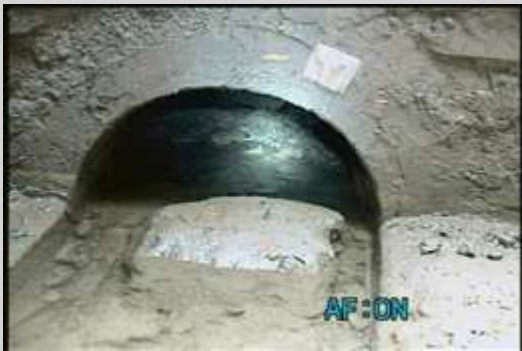
6 O'Clock Inflow

21 in. Circular Gravity Sewer
Pipe In @ 6 O'Clock

pipe at 6 and channel debris

Invert Depth: **4.34** (ft.) Flow Characteristics: **Slow**

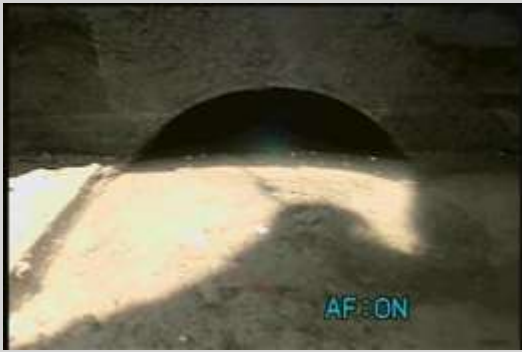
9 O'Clock Inflow

18 in. Circular Gravity Sewer

Pipe In @ 9 O'Clock

Invert Depth: **4.41** (ft.) Flow Characteristics: **Slow**

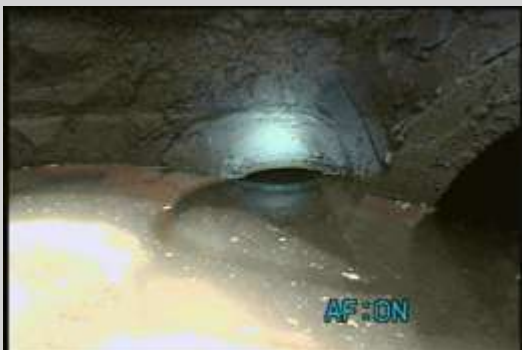
11 O'Clock Inflow

10 in. Circular Gravity Sewer

Pipe In @ 11 O'Clock

Invert Depth: **4.83** (ft.) Flow Characteristics: **Slow**
